Station Paper No. 55

December 1960

³
**A STUDY OF
EARLY GULLY-CONTROL STRUCTURES
in the Colorado Front Range**

by
Burchard H. Heede
Research Forester

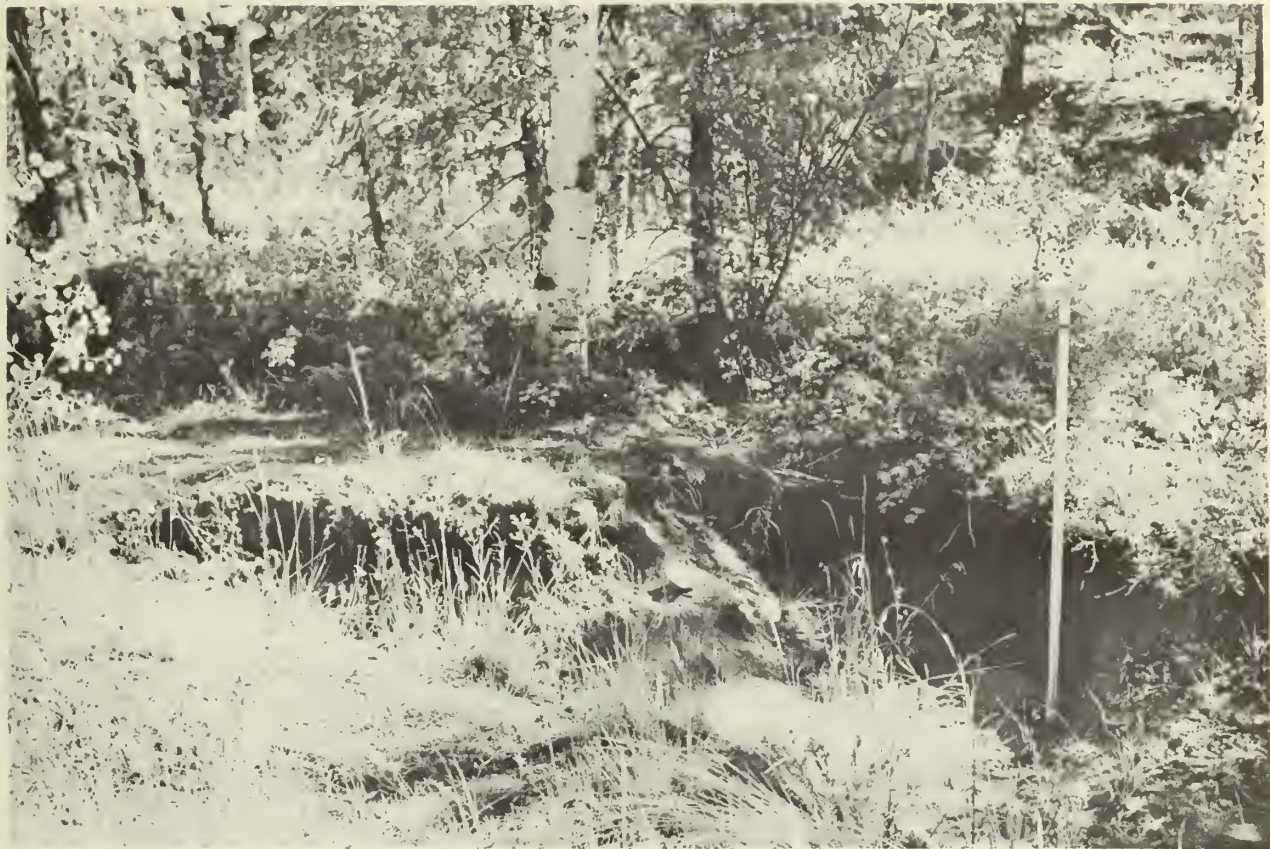
Figure 1.--The upper drainage of the Nursery gully follows an abandoned wagon road that is still visible where gullying has not taken place. Gully erosion is very active; headcuts mark the beginning of individual gullies. (Height of rod = 5.5 feet.)

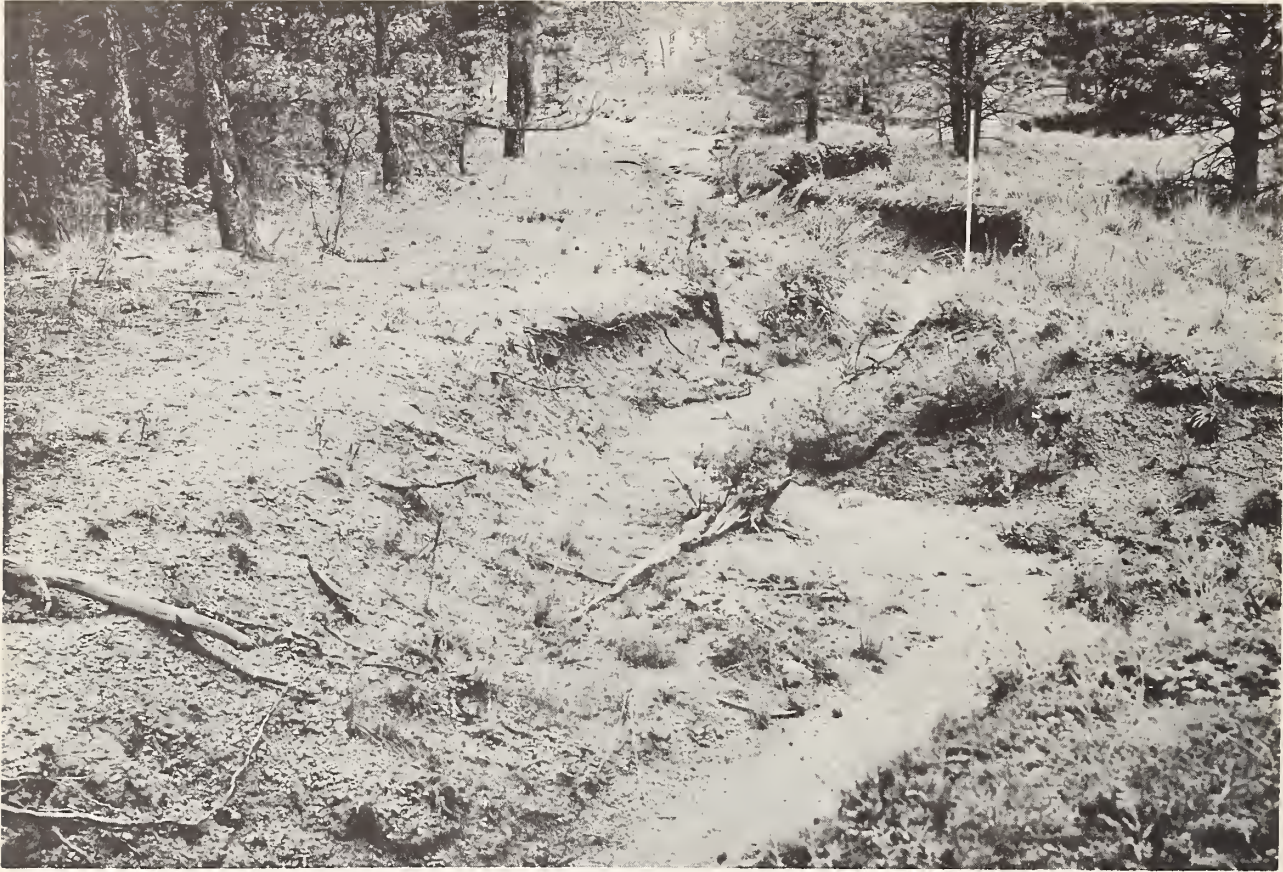
Figure 2.--Downstream view. The discontinuous gully loses depth rapidly downstream. Five discontinuous gullies follow each other until a fan, caused by sediment depositions, designates the end of this gully system. Here, the fan merges with the original valley floor. Sixty-five feet below this point the original valley bottom is dissected again by a headcut and a new string of discontinuous gullies begins. The total length of this upper drainage segment is one-quarter of a mile. (Height of rod = 5.5 feet.)

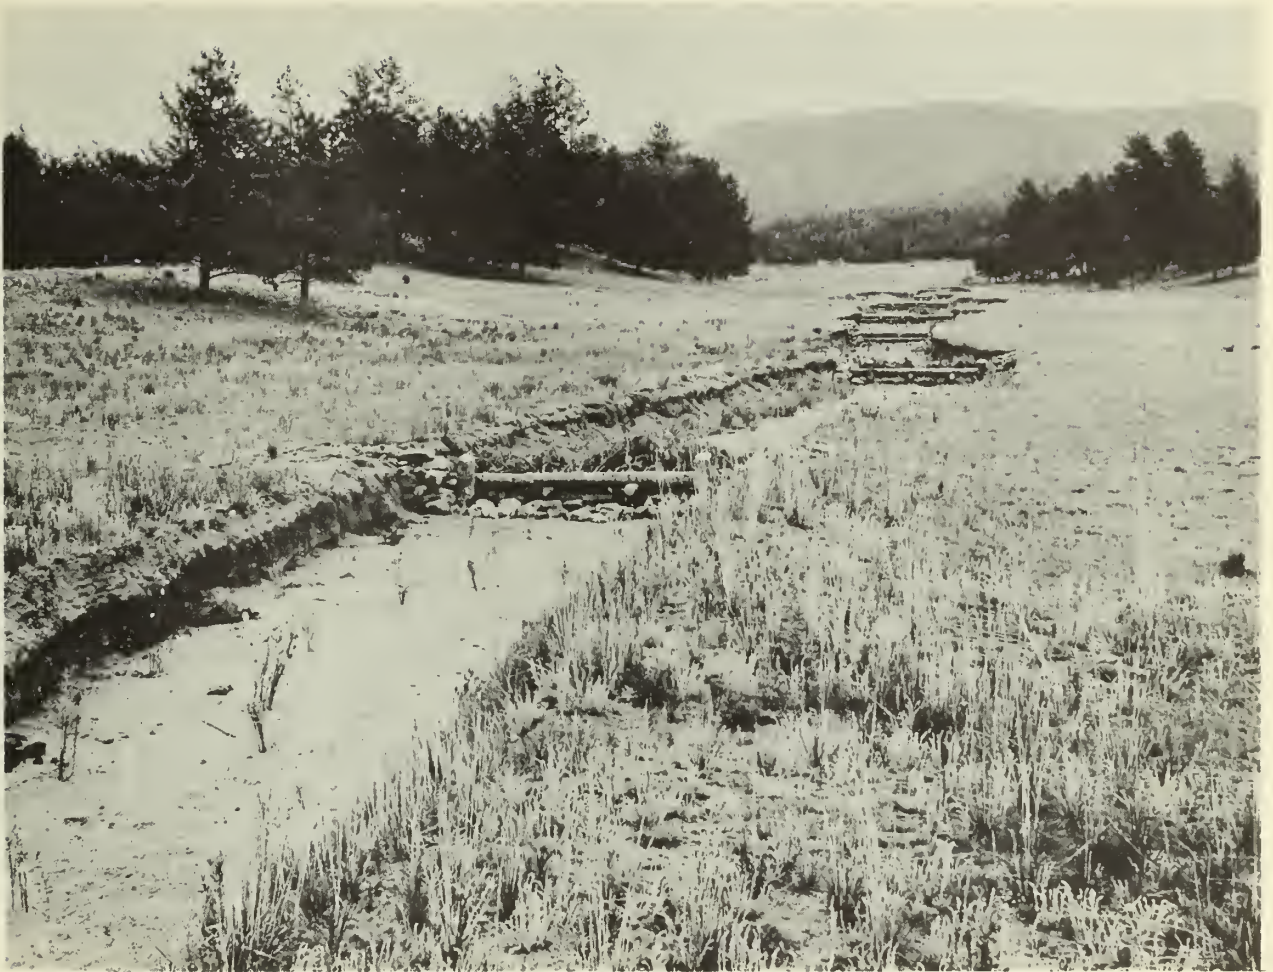
Figure 3.--Upstream view of a continuous channel photographed in July 1936.

This channel follows the string of discontinuous gullies and is 3,600 feet long. Headcuts of a small magnitude (0.5 to 0.75 foot deep) in the upper part of the continuous gully indicate that discontinuous channels joined into one continuous gully. This gully reaches a depth of 4 to 6 feet that is maintained downstream to a point close to the flood plain of Trout Creek. Here, the longitudinal channel profile becomes concave and channel depth decreases rapidly. In 1936-37 this continuous channel was treated by the Civilian Conservation Corps. Check dams and bank revetments were installed. Earth, logs, loose rock, and galvanized wire were used in the construction. Willow (*Salix* spp.) and New Mexican locust (*Robinia neomexicana* A. Gray) were planted in the channel and around the installations. Since the time of treatment, cattle grazing was reduced to a moderate intensity. Check dams were spaced in the gully by the rule that the height of the dam crest is in a horizontal line with the toe of the next upstream dam (head-to-toe rule). By this method stilling pond conditions were approached between dams and sediment accumulations were facilitated.

The lowest segment of the continuous Nursery gully illustrates reoccurrence of gully erosion caused by the failure of the dam at gully mouth. This dam was weaker than those installed upstream (see fig. 3). As a result of the structural failure, a new channel gradient was established that lowered the gully base level for 650 feet upstream. The headcut undermined four check dams and is still active (see fig. 21).

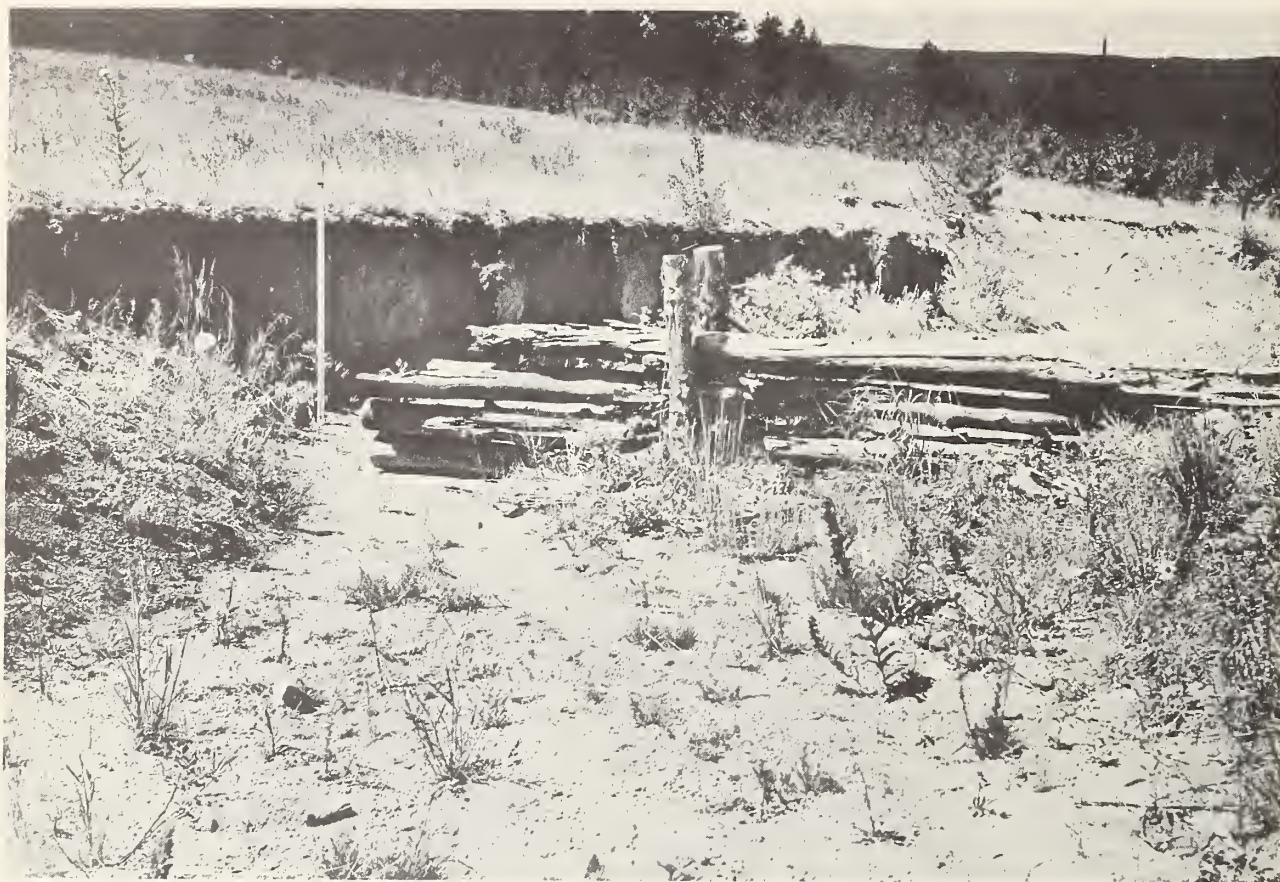
Figure 4. --Structure No. 1 is the first check dam installed in the upper reach of the continuous gully. The log dam was keyed 2 feet into the solid channel bank and reinforced by layers of loose rocks. The stream went around one end of the dam and widened the gully 5 feet as shown by the vertical bank. This widening probably took place soon after the structure was installed.

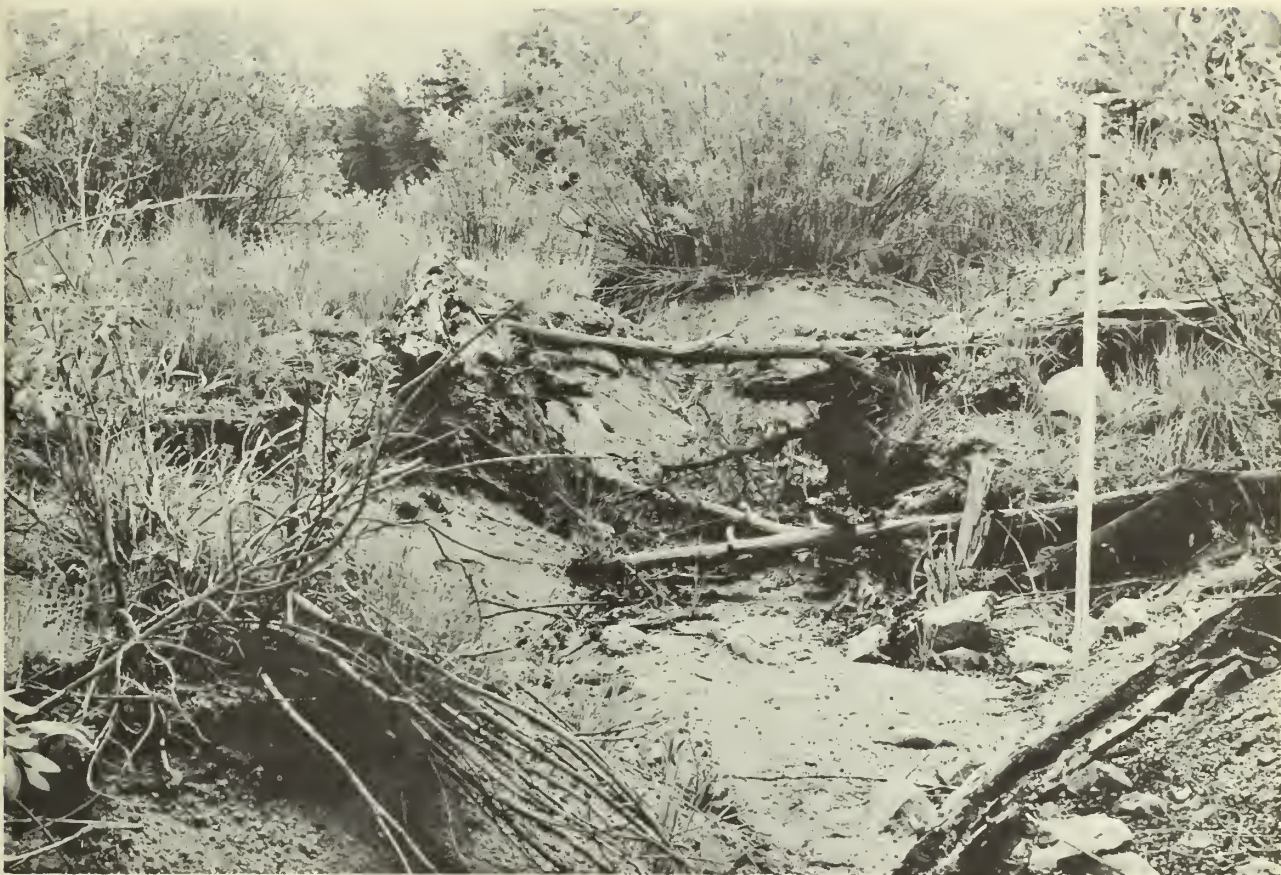
Figure 5.--At structural site No. 10 a headcut undermined the double log dam in the center. This headcut is now 12 feet upstream from the structure and is still active. The individual dams of the structure were connected by beams and the logs were tied with wire. Originally, the space between the dams was filled with earth and tree branches. Sediment accumulated to a height of 3.5 feet behind the dam. Planted willow and locust grow on the deposits.

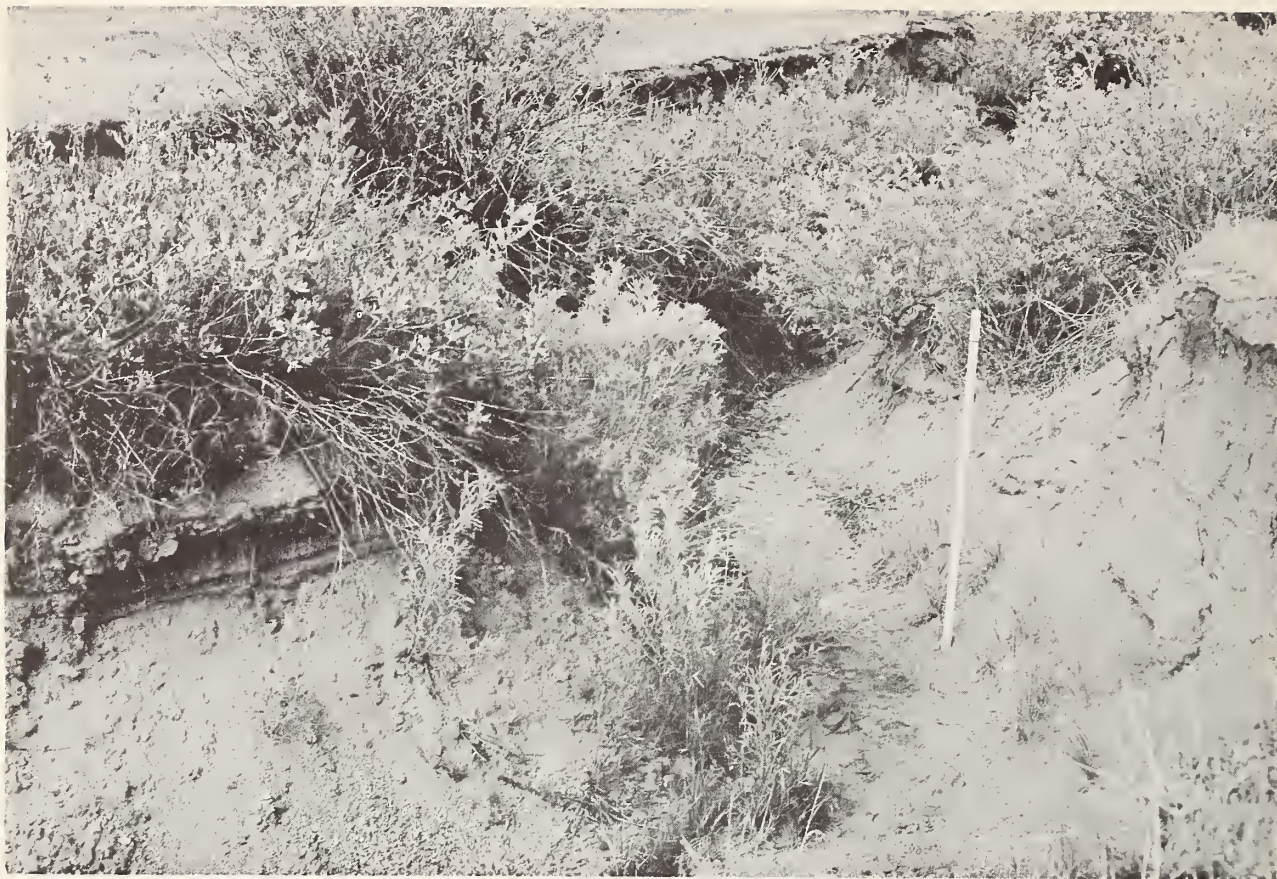
Figure 6.--In the channel reach below structure No. 10 a new gully, caused by the headcut shown in figure 5, dissects the sediment deposits that were accumulated by a lower structure. The new gully meanders around the willow stands. With increasing channel depth the flow undercut the willows, tumbling them into the new gully. Erosion was accelerated by the soil loosened by the falling willows. (Height of rod = 5.5 feet.)

The proper design of erosion-control structures is of great importance for successful gully treatment. Overdesign results in unjustifiable expenditures. Underdesign of one check dam can cause damage to all other installations upstream. This allows accelerated erosion to take place at a rate often greater than that in an untreated gully (see fig. 6).

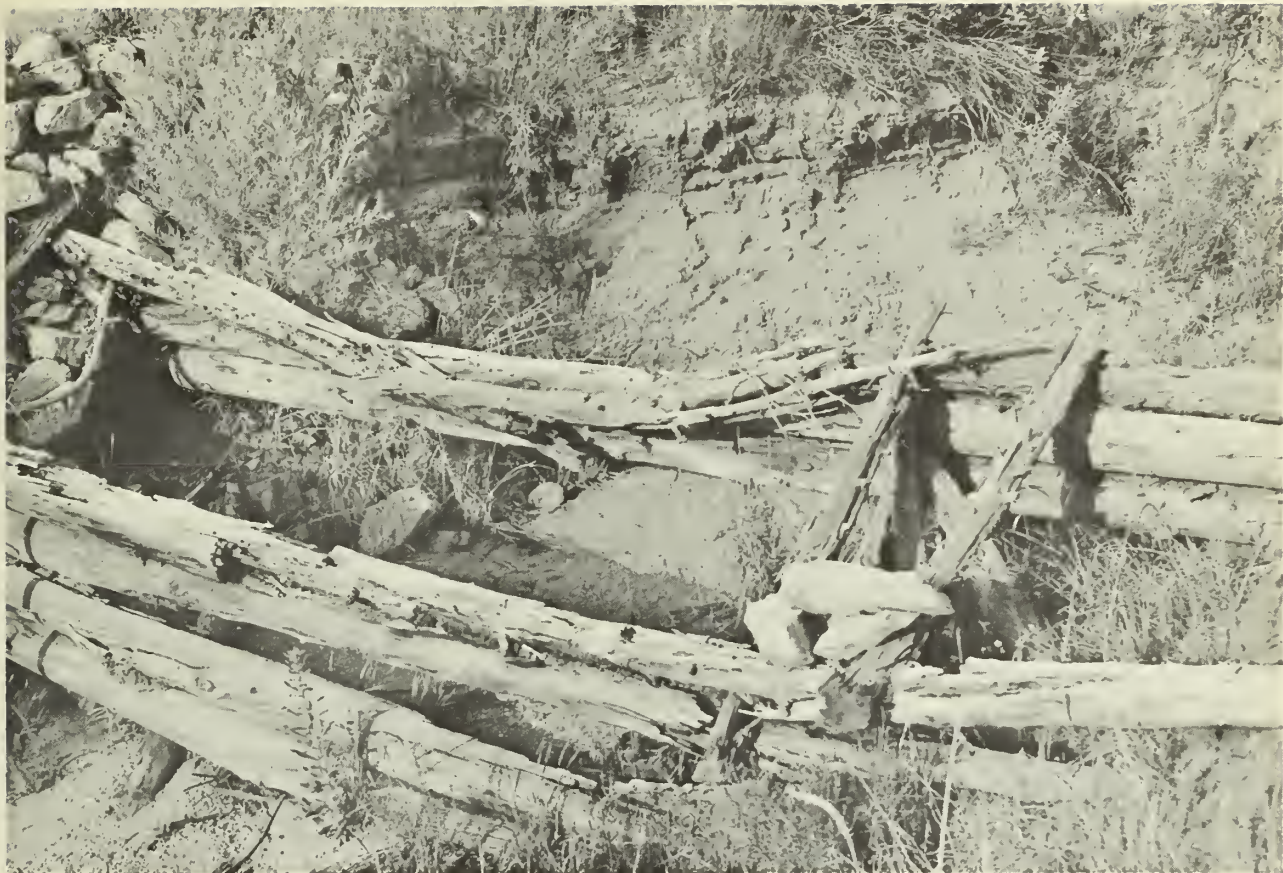
Figure 7.--(Upstream view.) Dam No. 11 accumulated considerable sediment until the headcut, presently located at structure No. 10, progressed through the dam and undermined it. The present channel is 2.5 feet lower than the original channel at time of treatment.

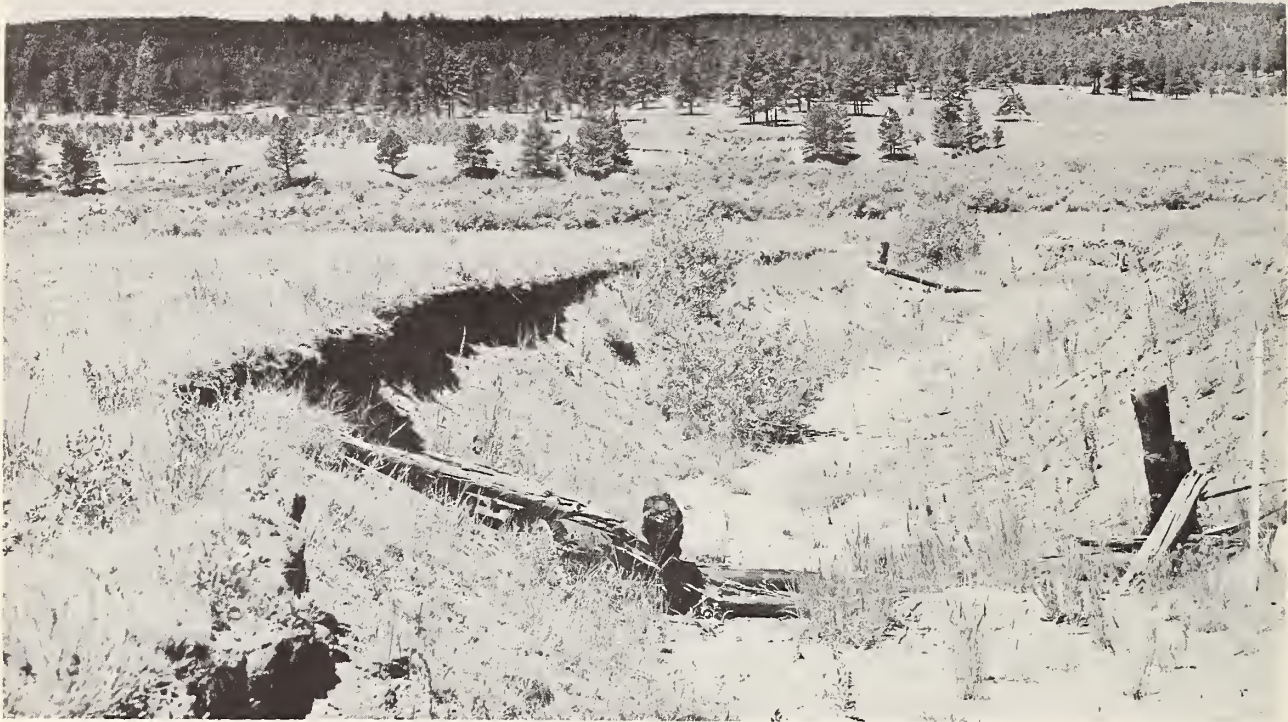
Figure 8. --Dams No. 12 and No. 13 are the last structures in the gully. Dam No. 13 was installed 180 feet above the gully mouth. The dimensions for this dam site were as follows:

Estimated channel cross section at time of construction = $11 \times 19 \times 5$ feet;

Present channel cross section = $20.5 \times 27.5 \times 5.3$ feet.

The estimated original structural dimensions were:

Height of dam = 4.2 feet;

Length of dam crest = 12.5 feet.

Both structures failed. The channel bottom at dam No. 12 was lowered by 1 foot since time of construction; the base level at dam No. 13 stayed at approximately the same elevation.

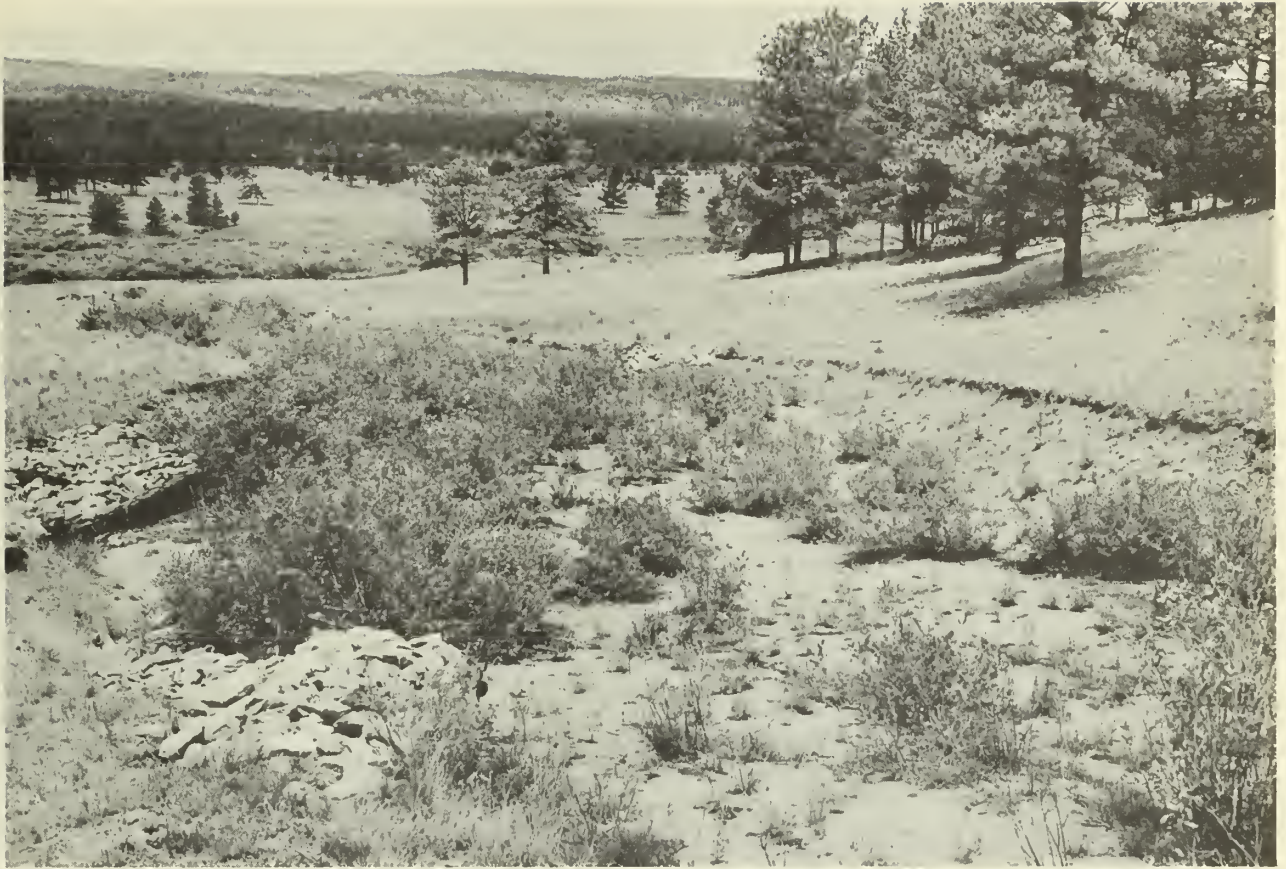
Figure 9.--Where the main gully and a tributary join, crib jetties were installed at a 45° angle to the direction of the main stream. The flow from the tributary forces the main stream against the bank opposite to the point of inflow. Here, the gully had widened before the jetties were built. No bank erosion occurred after treatment. The opposite bank shows signs of cutting that took place during the early years of treatment.

Figure 9 illustrates revetments that are placed at the point of confluence of the Nursery gully and a tributary. These crib jetties direct the flow toward the opposite bank where scouring took place. Revetments, installed parallel to the bank, would have been more effective.

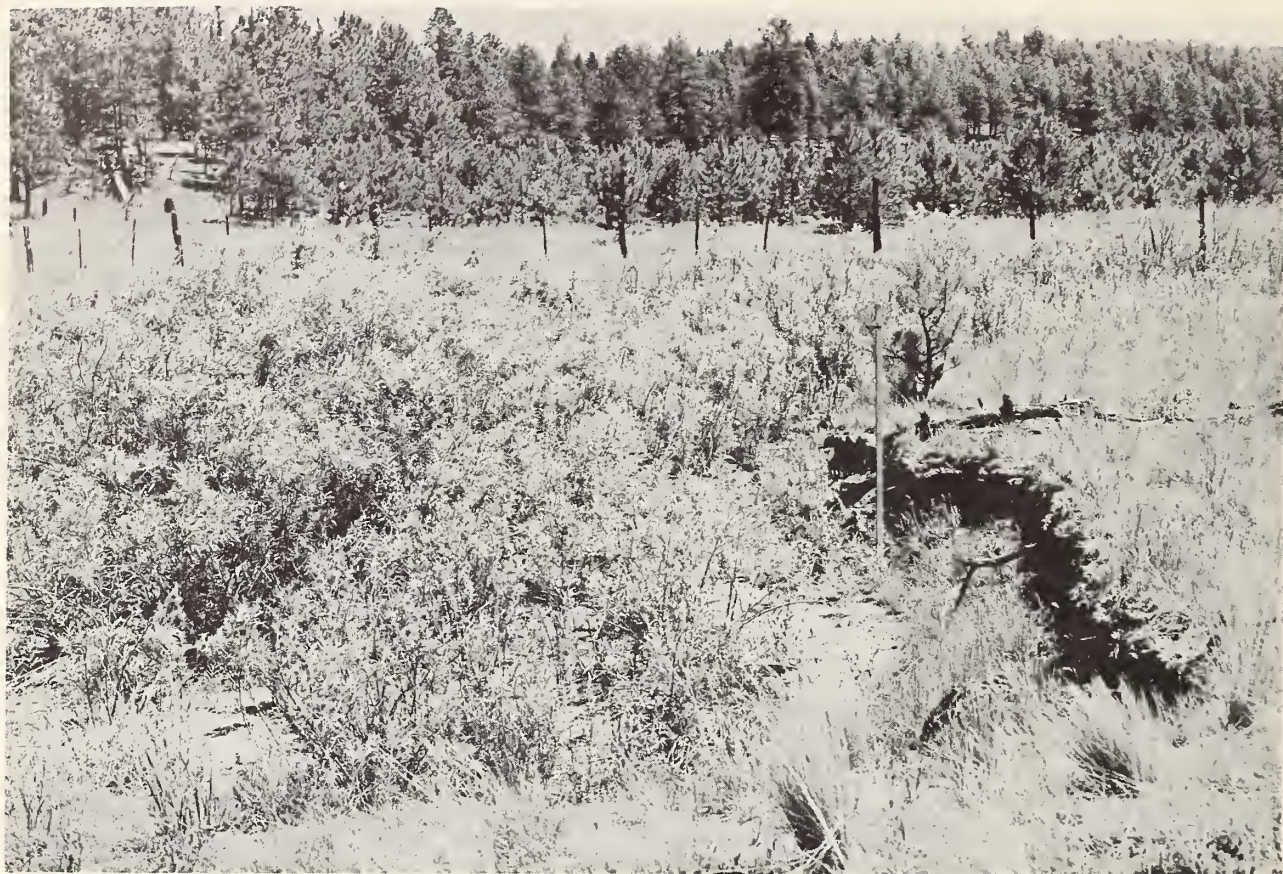
Figure 10. --Willow plantings in the erosion channel survived well, but only a few locust plantings survived. In some places very dense stands of willows developed from root cuttings. Flows of high velocity moved these cuttings downstream. Where the velocity decreased, the cuttings were deposited and grew into dense stands. Often the gully had widened where these dense stands occurred.

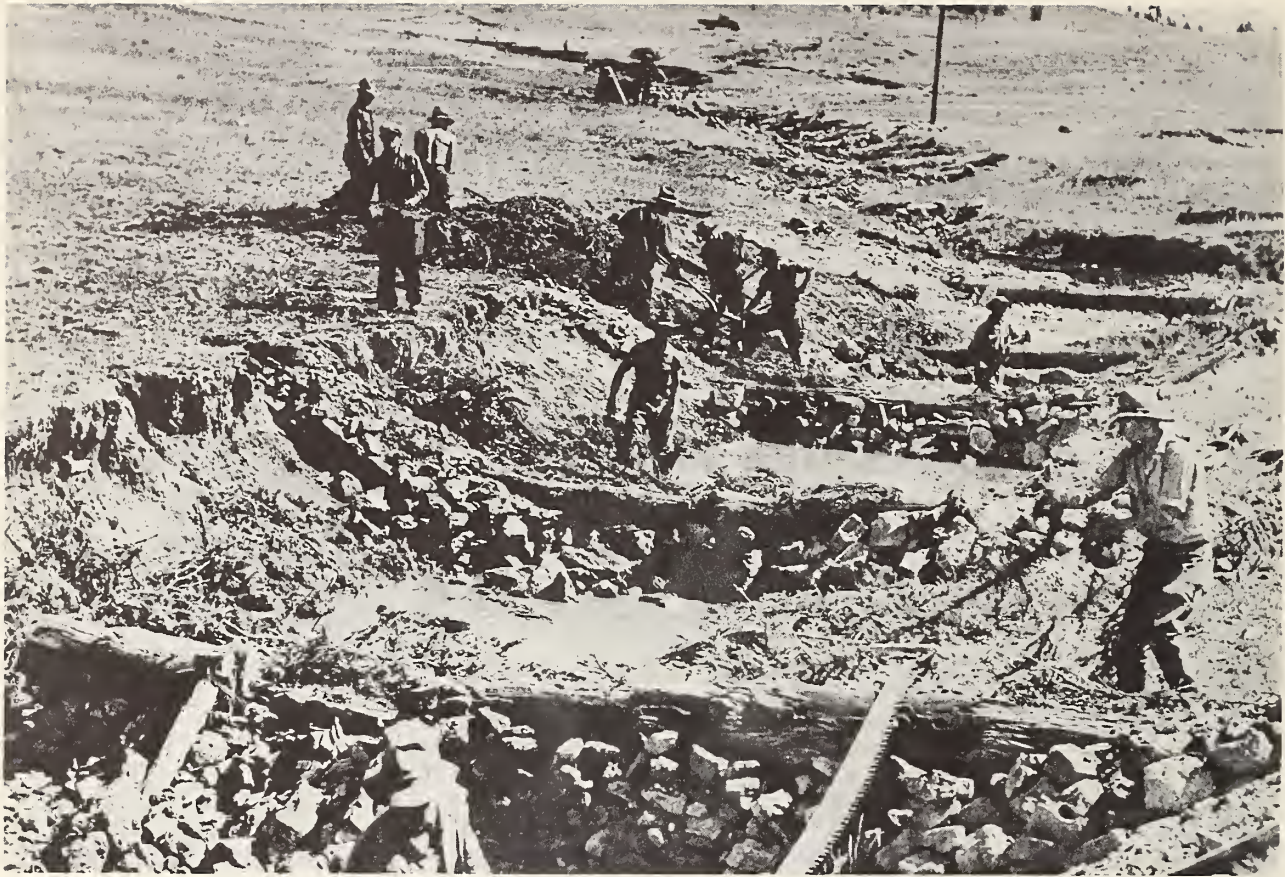
Figure 11.--In 1933-34, the U. S. Civilian Conservation Corps treated the gully by check dams and willow plantings. In the upper part of the watershed shown here the channel banks were graded to an angle of rest. Since 1937 no livestock have grazed the national-forest land that makes up about 90 percent of the watershed. The remaining 10 percent is State owned and lies at the drainage mouth. Here, grazing continues. Treatment started in the headwater area where small check dams made of logs or loose rocks were spaced 5 to 10 feet apart in the shoestring gullies. In the main gully, the spacing was determined by the head-to-toe rule, and many structures were installed. This is illustrated by the following data:

Length of channel segment = 825 feet;

Number of check dams = 28;

Average distance between structures = 29.4 feet.

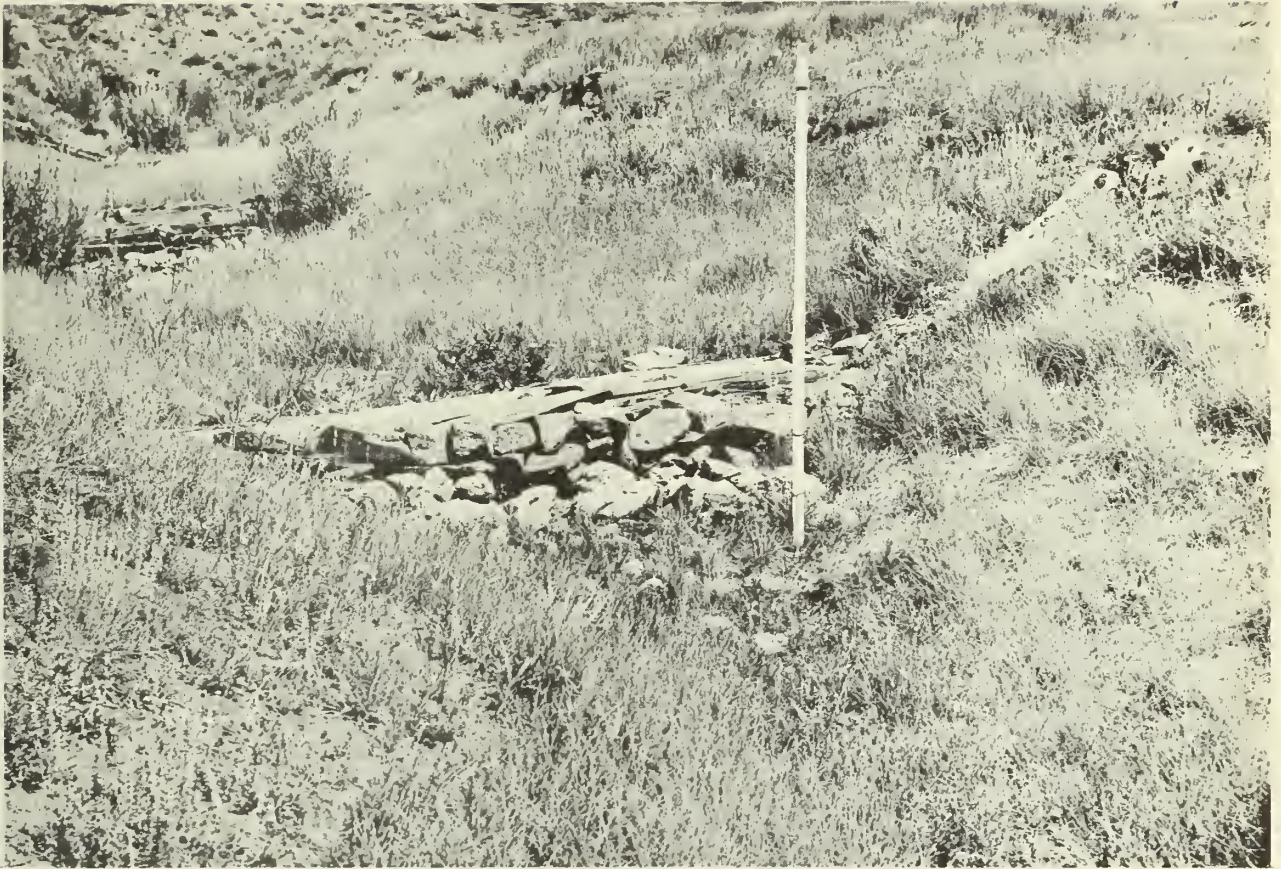
Figure 12.--View looking upstream at structure No. 5. This is a successful log dam reinforced by loose rocks. It is anchored 2 to 3 feet deep into the solid channel banks. Logs, installed into the slots of the dam keys, extended about 1 foot into the channel and the crest of the waterfall could not touch the banks. Below the dam an apron of loose rocks is imbedded in the gully floor. The gully banks were graded to the angle of repose. (Height of rod = 5.5 feet.)

Since vegetation cannot be established on vertical slopes, banks with steep slopes should be brought to an angle of repose where channel depth is not excessive. This measure was performed successfully in upper Trout Creek gully where the gully was continuous and banks were less than 5 feet high (see fig. 12).

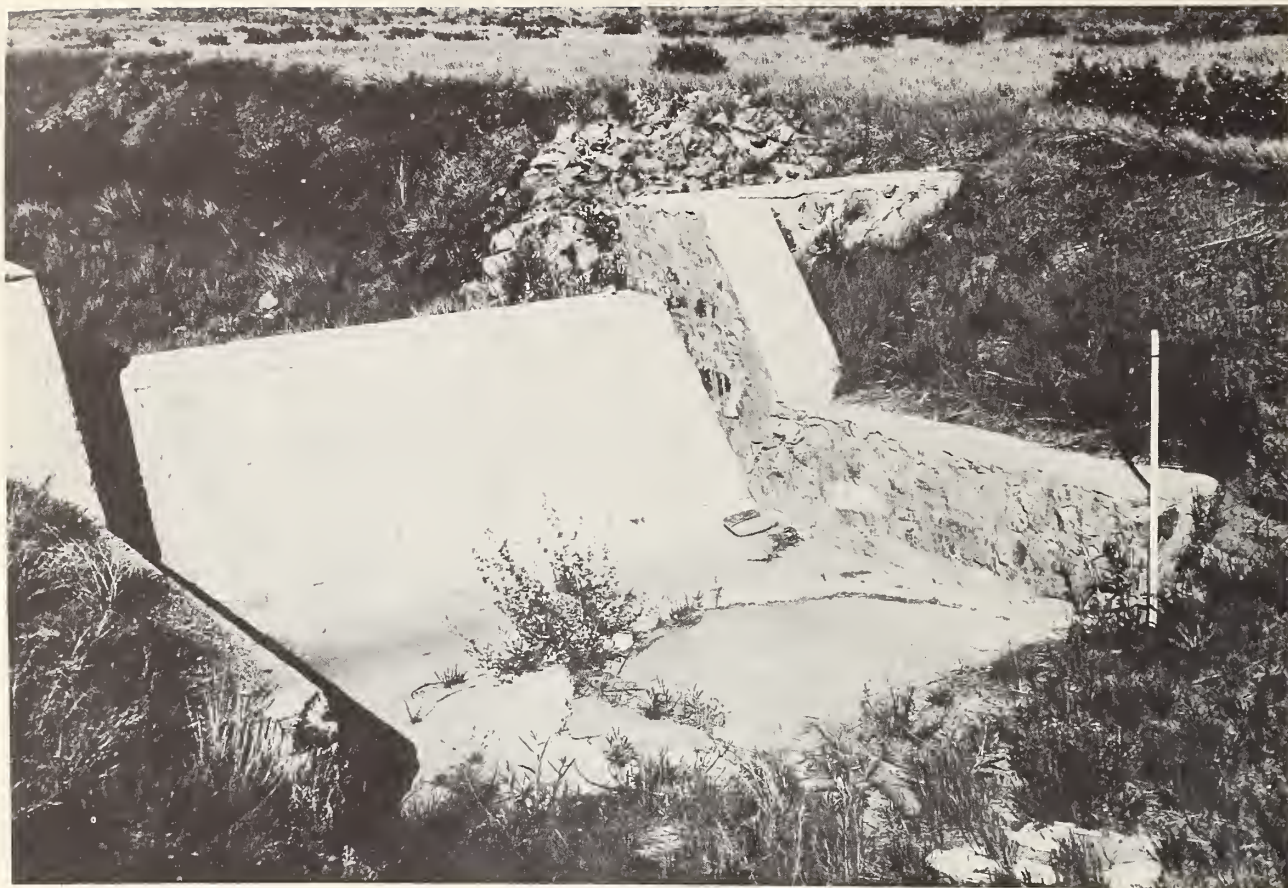
Figure 13. --Further downstream the gully bordered U. S. Highway 24 before the relocation of the highway in 1938. As this gully segment still eroded following treatment, the log and rock check dams were replaced by five masonry drop structures in 1937. Their heights range from 5 to 5.5 feet. All dams were successful. The upper three structures accumulated sediment to spillway crest, while at the two lower structures sediment depositions remained 2 to 3 feet below dam height. Since the concrete is deteriorating, the masonry structures need repair.

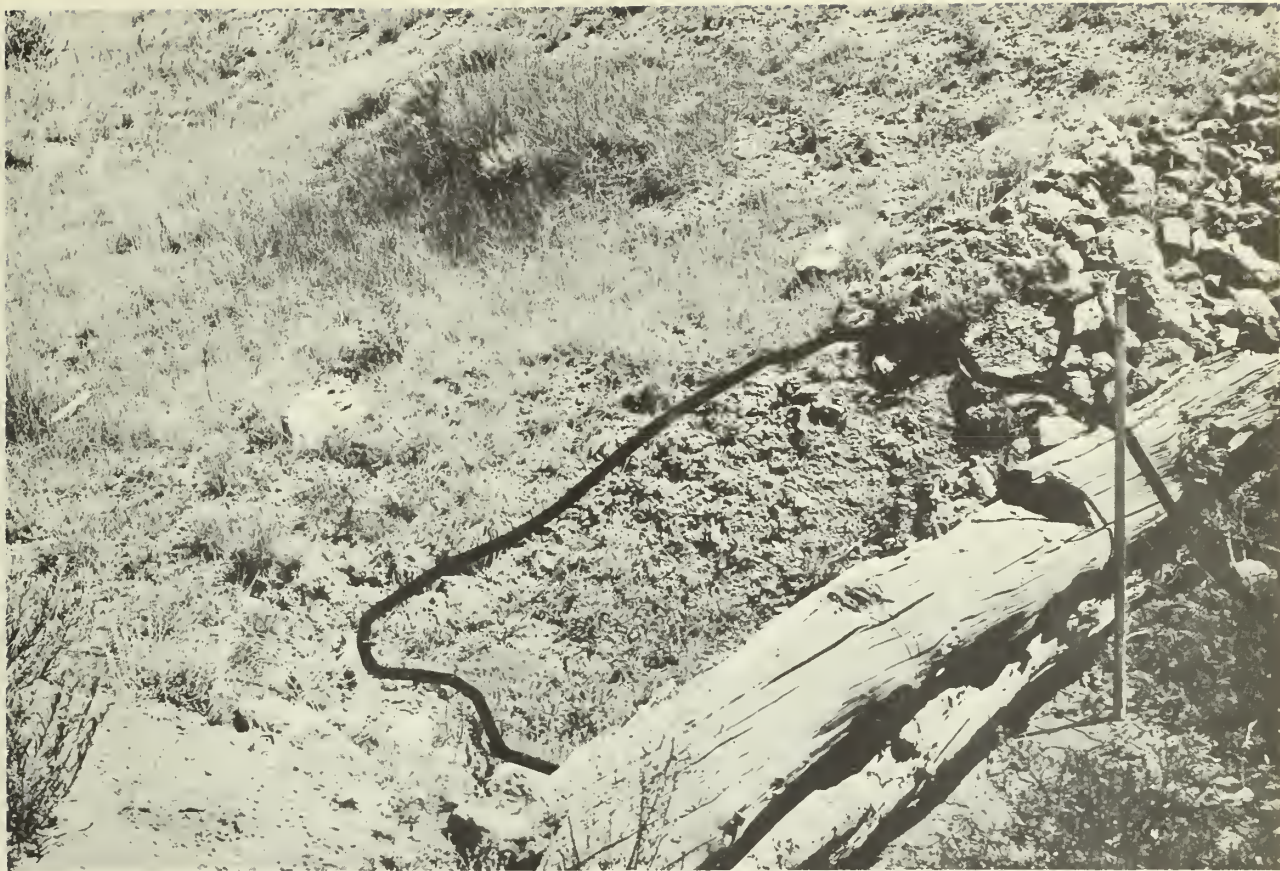
Figure 14. --At a distance of 210 feet below the last masonry structure a headcut in the channel bottom undermined check dam No. 37 to a depth of 1 foot. (Height of rod = 5.5 feet.)

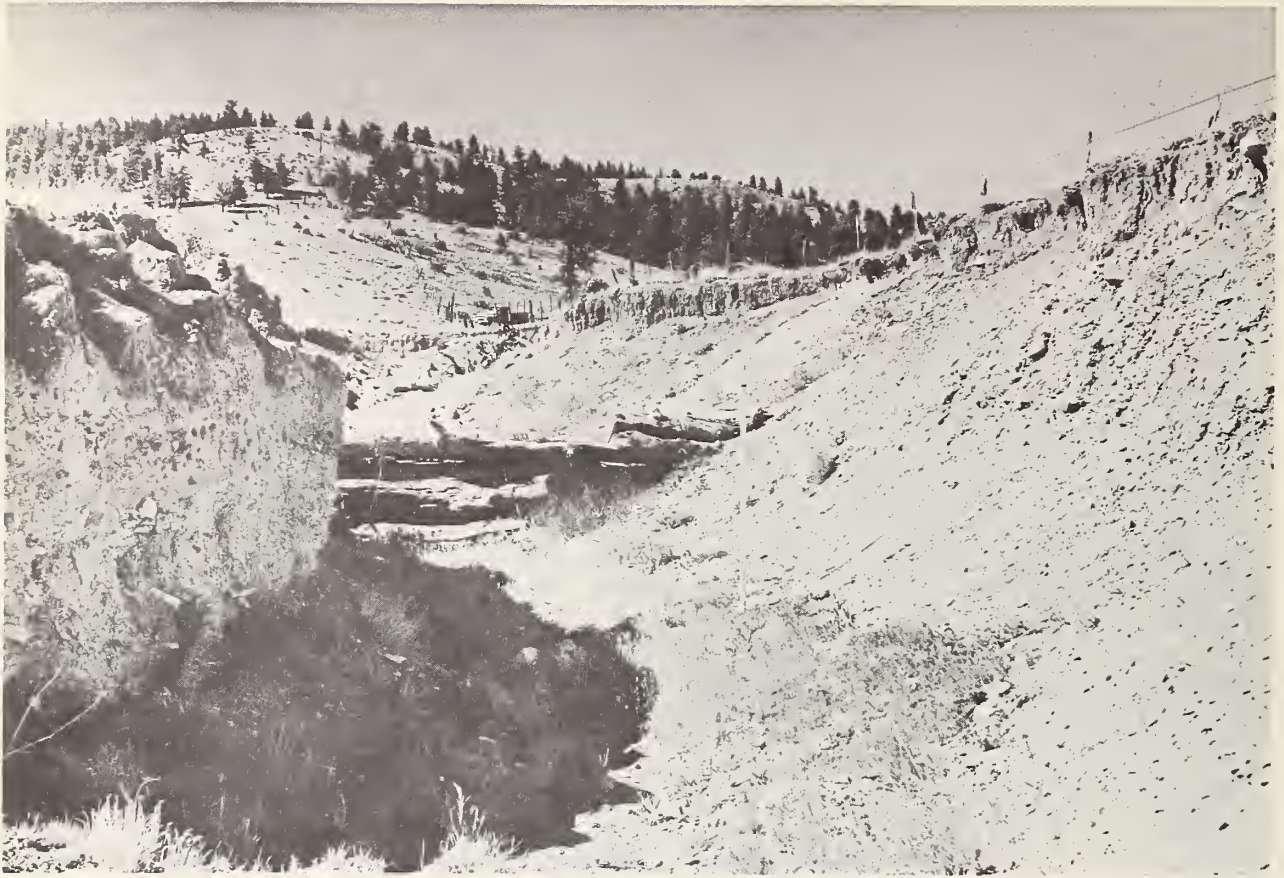
Figure 15. --Beginning at the headcut shown in figure 14, channel depth increases rapidly downstream to 12 feet. Structure No. 45, located 490 feet downstream from the headcut, was undercut like all other dams in this segment. Cattle still graze the pasture to the left of the gully, but cattle grazing on the right bank was halted 22 years ago. The left bank is eroding faster than the right. (Height of rod = 5.5 feet.)

In ephemeral gullies, banks may also be steep in straight reaches. A dense plant cover protects the rim of the channel more efficiently than a depleted cover (see fig. 15).

When the structures failed, a new channel gradient was carried upstream by headcutting. This headcut is now 0.5 mile upstream from the structures that failed and 100 feet above the national-forest boundary. While moving upstream, the headcut undermined and destroyed 15 check dams (see fig. 15).

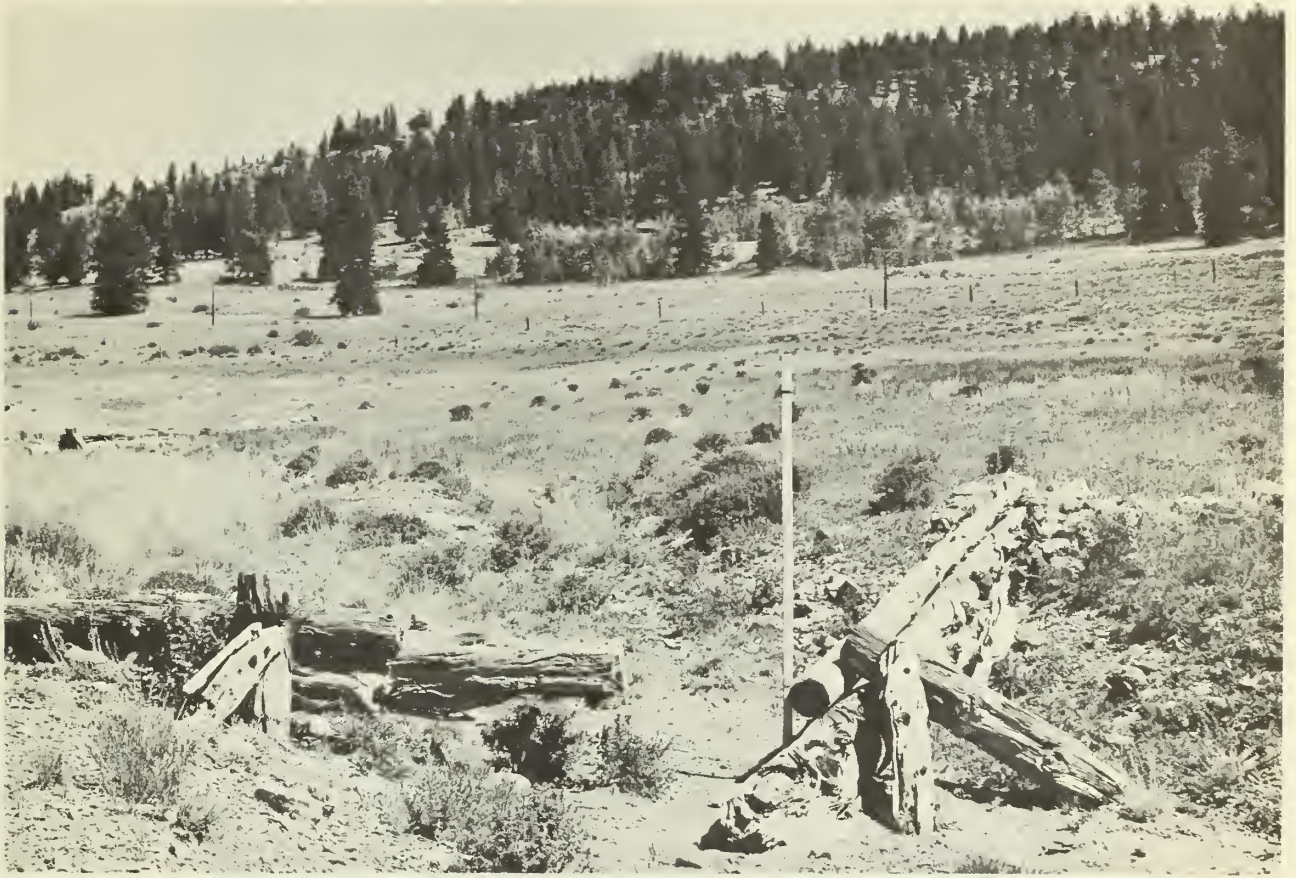
Figure 16. --Half a mile downstream from the headcut in figure 14, the gully becomes concave and gully depth decreases. Three V-shaped log dams were installed in this channel reach. Dam height equaled or exceeded channel depth, and the structures pointed downstream. Small spillways were provided in the center of the structures. All three dams lost their effectiveness when the two wings of the dam were pushed apart by the impact of a flash flow.

The upper segment of the gully is well stabilized by vegetation (see fig. 12) and the deterioration of the log dams does not cause an erosion hazard. Inspection showed that control of the total system may be lost if treatment is not applied to the main critical location that lies 1.25 miles below this stable segment. Here, check dams failed because of inadequate design and construction (see fig. 16).

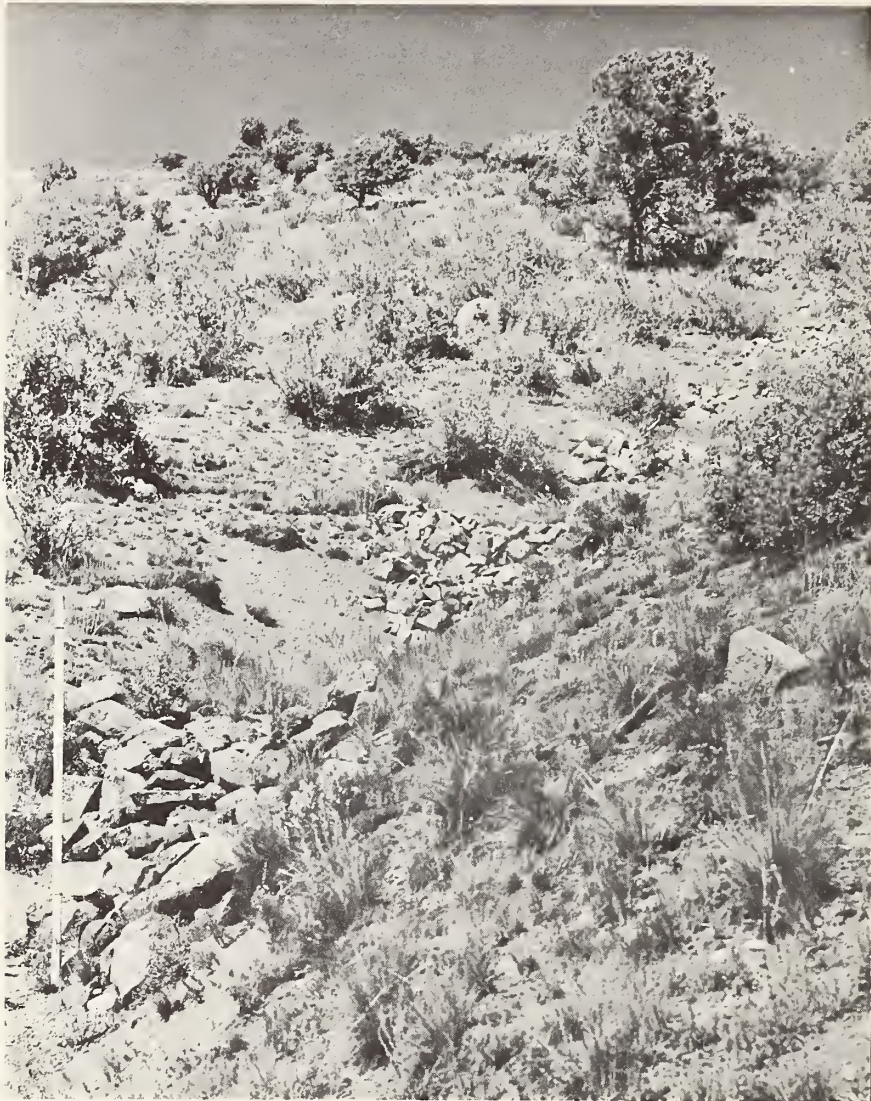
Figure 17. --Small Tributary gully is 377 feet long. The channel gradient averages 31.5 percent. The average channel cross section, computed from the cross sections at the structural sites, is 11.3 square feet; 2.3 feet is the average gully depth. Loose-rock check dams were installed in the 1930's. The average spacing between the dams is 21 feet. Fifteen of the 18 check dams restricted all the flow; none failed.

Expected peak flow at the structural sites and discharge capacity of the check dams were calculated. From these calculations it was found that no structural failure occurred when the flow was less than 8 c.f.s. (see fig. 17). With this volume of runoff the related hydrostatic and dynamic forces are too small to cause destruction. (Calculations for all of the structures studied are presented in table 1, page 42.) This condition is represented by Small Tributary gully that lies in the headwater area of a larger drainage. The expected peak flow was estimated to be 1 c.f.s. at the gully mouth. No dam failed regardless of whether it accommodated the flow.
